Insight Home Inspection Services
(865) 274-0808
www.inspectedbyinsight.com
info@inspectedbyinsight.com

Home Inspection Report

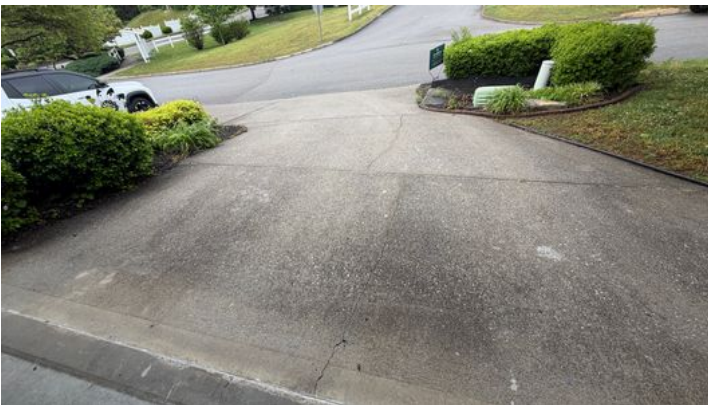
Driveway shows some settlement cracking but is still usable.

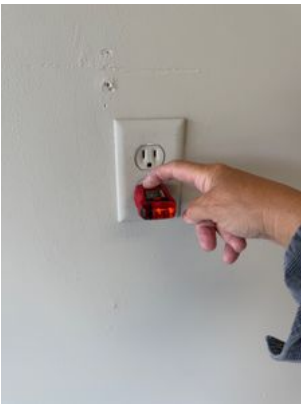
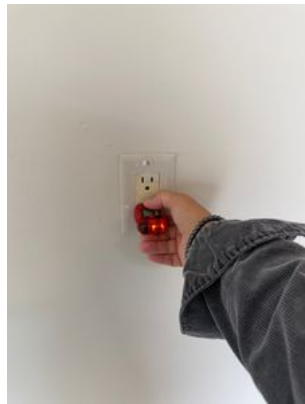
GFCI receptacles recommended at garage area.

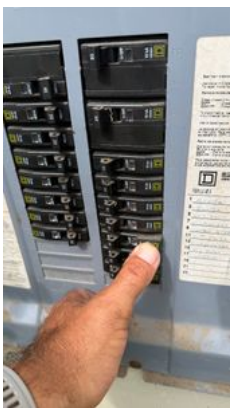
GFCI / AFCI breaker would not trip. Recommend further electrician evaluation and repair as needed.

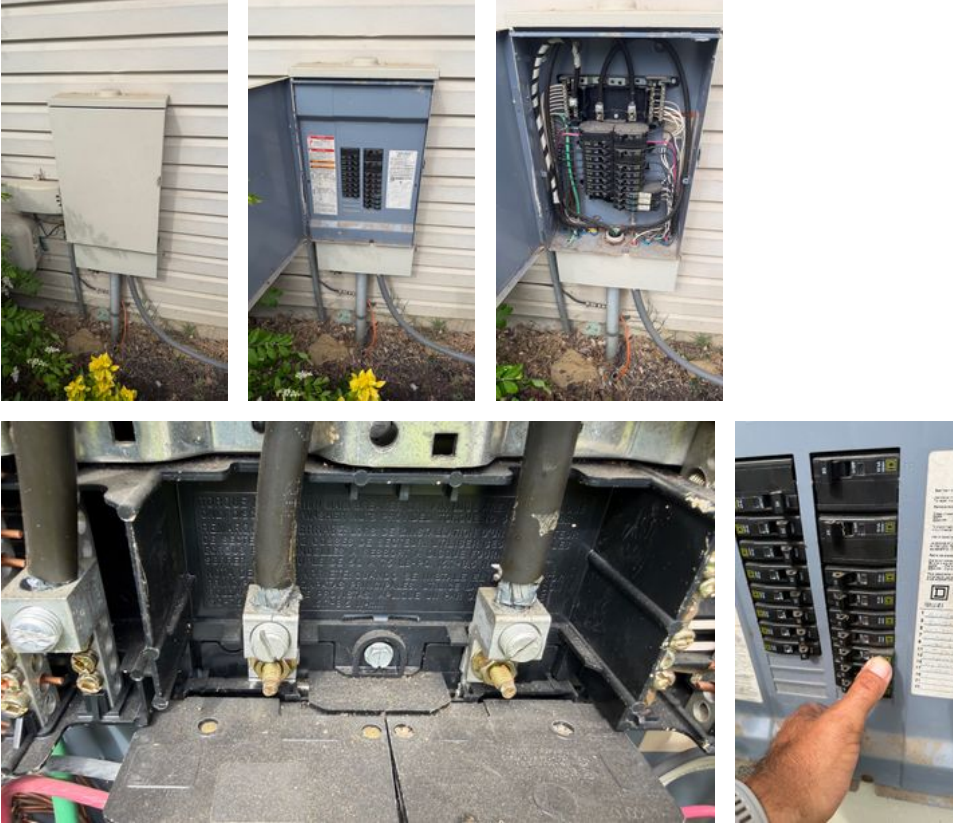
Panel size appeared to be compatible to service size.

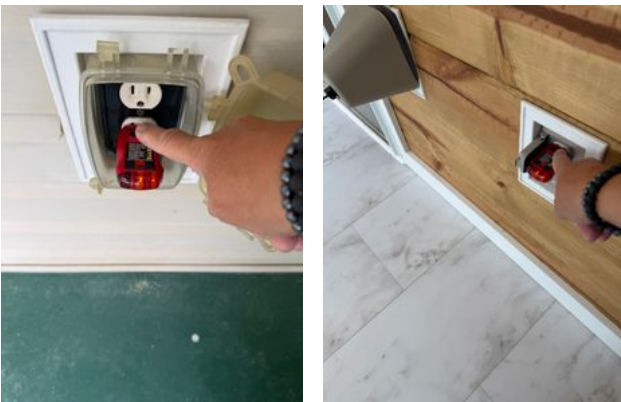
GFCI receptacles and weatherproof receptacle covers recommended at exterior.

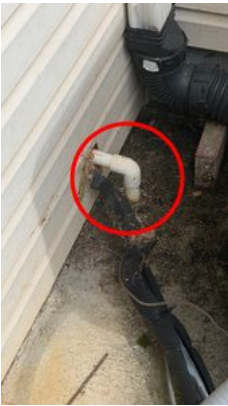
The HVAC condensate drain terminated less than 12 inches from the home's foundation. This can allow water to collect near the structure and contribute to moisture intrusion or foundation settlement over time. Recommend extending the drain line to discharge further away from the home.

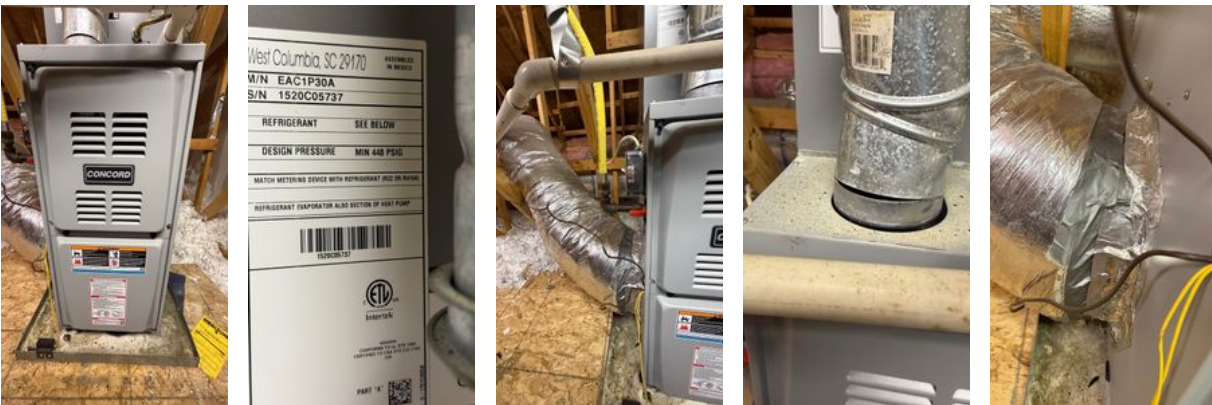
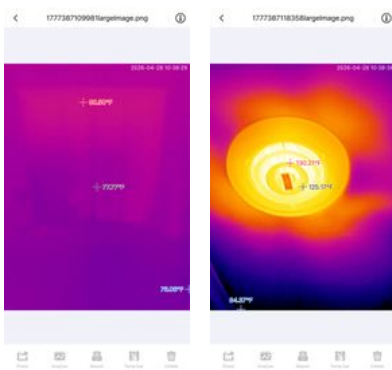
HVAC was in normal working order at the time of the inspection. An HVAC technician evaluation and cleaning can extend the life of the units. These photos represent the temperature differences between the intake and output.

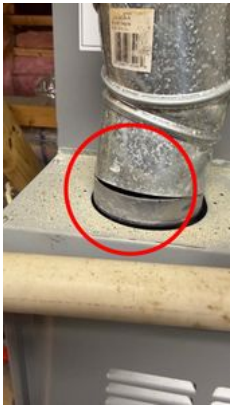
Improperly installed flue connection with visible gap at furnace. Potential for exhaust gas leakage. Recommend repair.

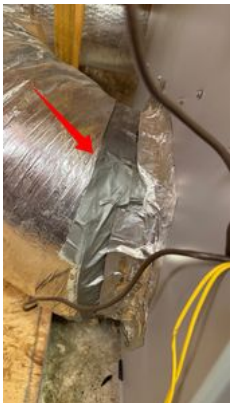
Flex duct improperly secured at air handler. Tape used in lieu of proper fastening. Air leakage likely. Recommend correction.

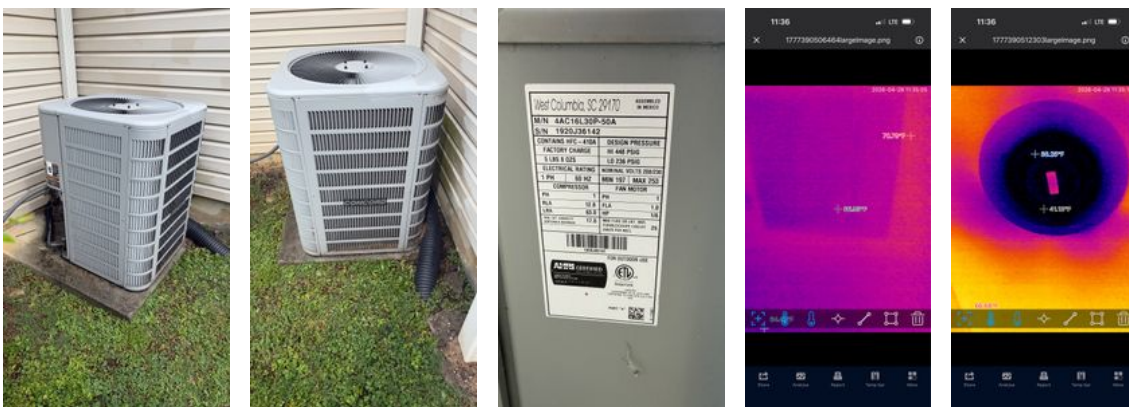
HVAC was in normal working order at the time of the inspection. A periodic HVAC technician evaluation and cleaning can extend the life of the units. These photos represent the air difference between an intake and output, which is well within means.

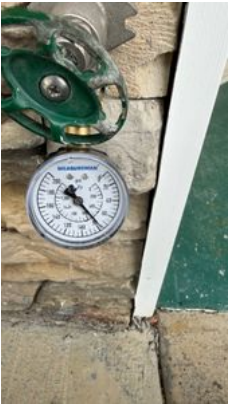
Water pressure is satisfactory between 40-80 psi.

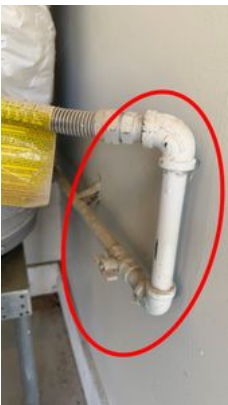
Recommend installing drip legs at gas supply lines as needed. None visible.

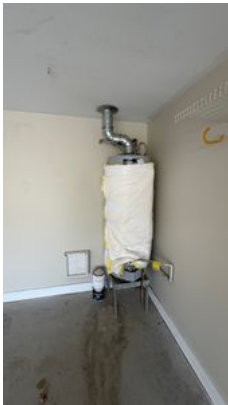
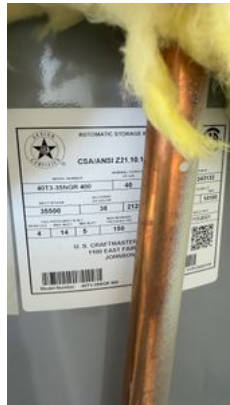
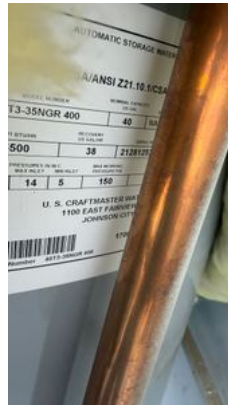
Water heater(s) was/were in normal working order at time of inspection. An expansion tank is recommended.

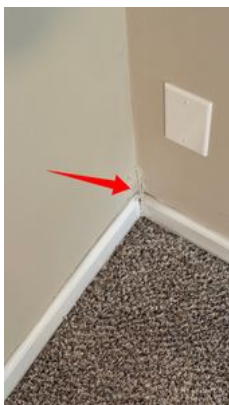
Moisture damage noted at wall base/corner. Likely ongoing or recurring. Source unknown. Recommend evaluation and repair.

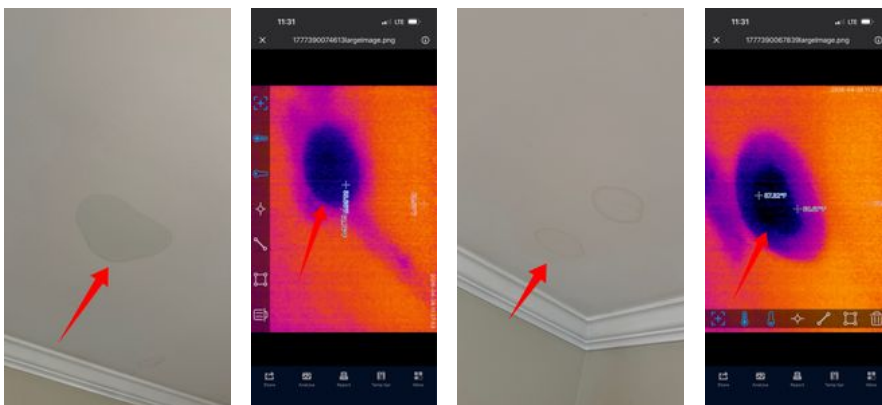
Ceiling is actively wet with visible staining. Source unknown. Recommend immediate evaluation and repair.

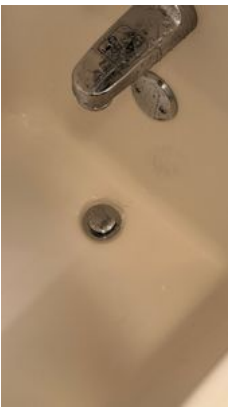
Tub drain plug needs repair / adjustment to function properly.

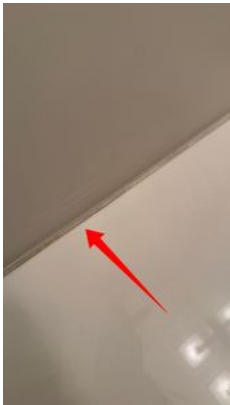
Recommend caulking / sealing countertop edges and backsplash when needed.

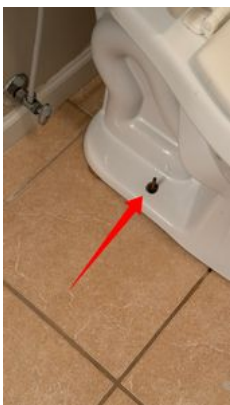
Missing toilet base caps, they help protect the bolts from corrosion and prevent dirt or moisture from collecting around them.

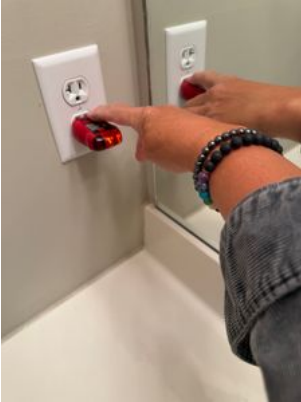
GFCI receptacles recommended within 6' of water sources. (Kitchen, bathroom (s), laundry room, etc.)

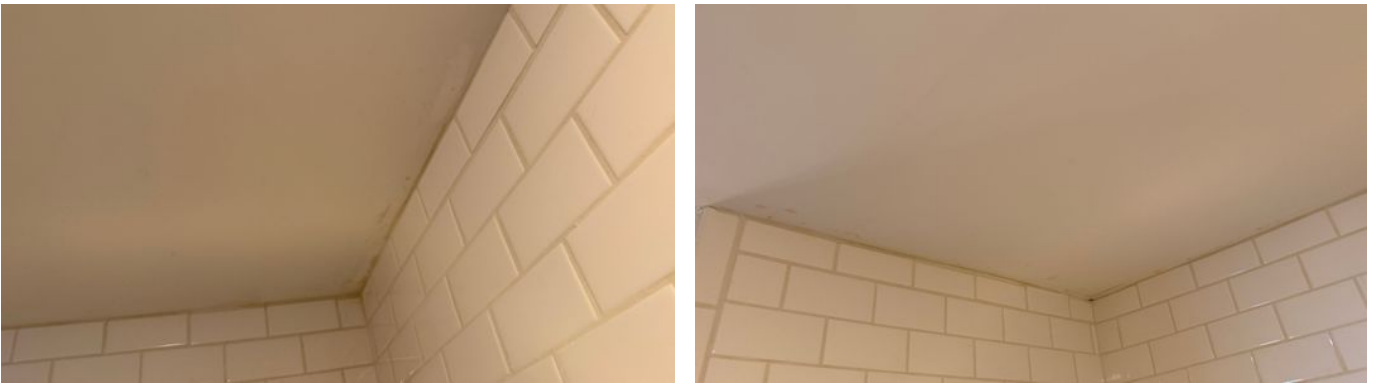
The bathroom ceiling above the tub/shower shows signs of moisture damage. Further evaluation and repair are recommended.

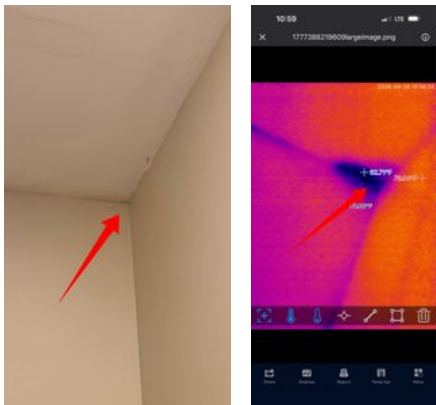
Active moisture noted at master bathroom ceiling above toilet. Thermal anomaly and visible damage present. Source unknown. Recommend immediate evaluation and repair.

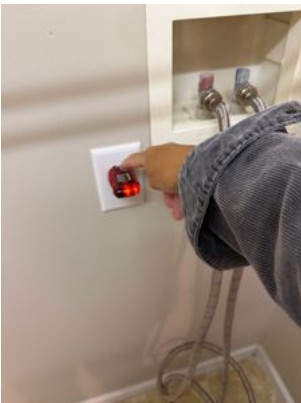
GFCI receptacles recommended within 6' of water sources. (Kitchen, bathroom (s), laundry room, etc.)

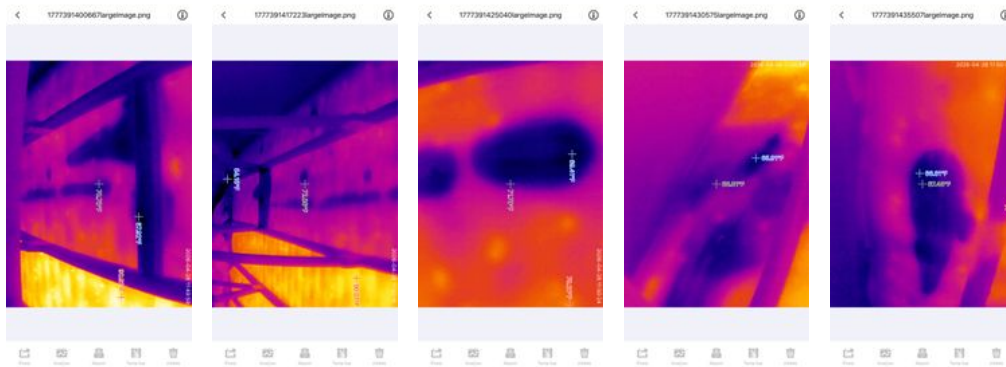
Thermal anomalies noted at roof sheathing/drywall interface consistent with possible moisture intrusion. Recommend further evaluation.

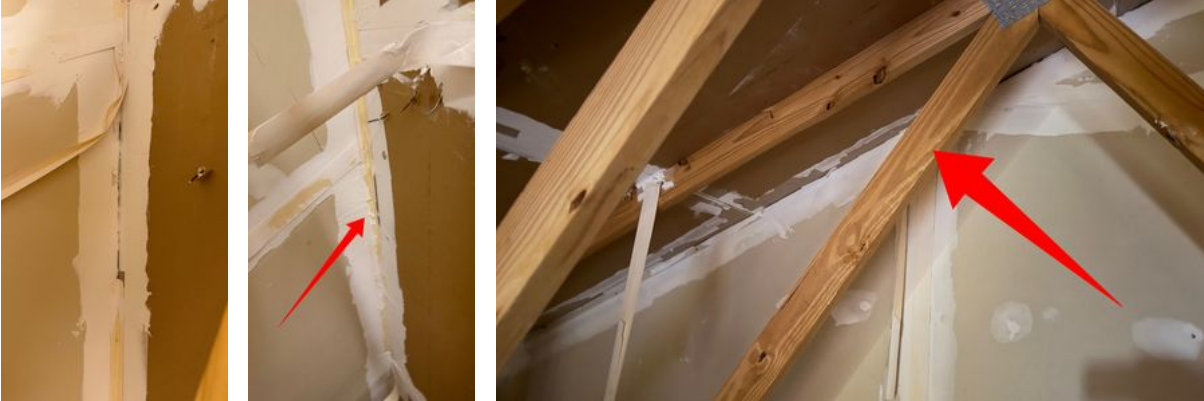
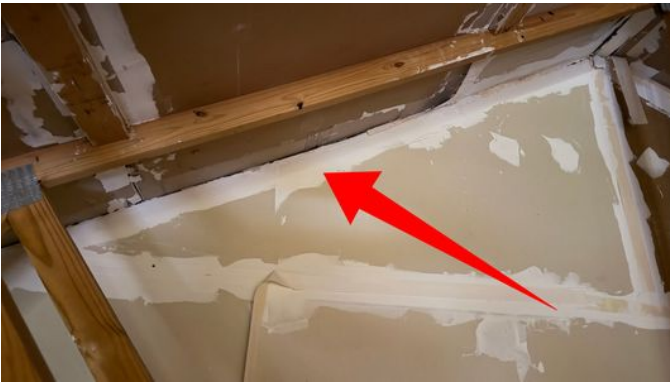
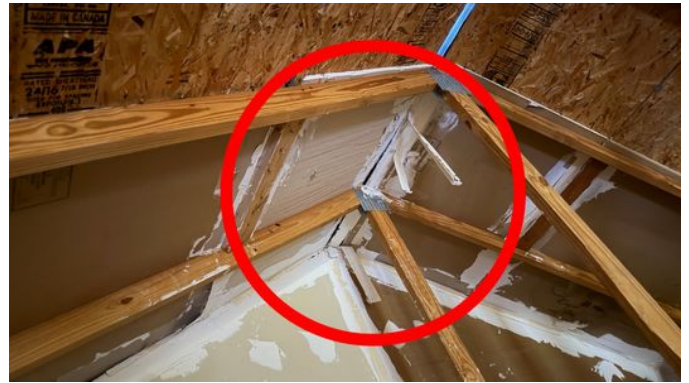
improper fire separation with openings—needs to be sealed and corrected, not just cosmetically patched.

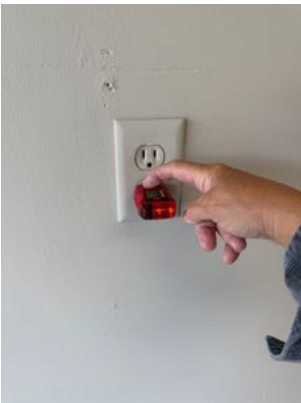
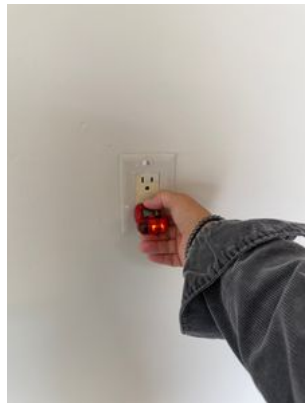
GFCI receptacles recommended at garage area.

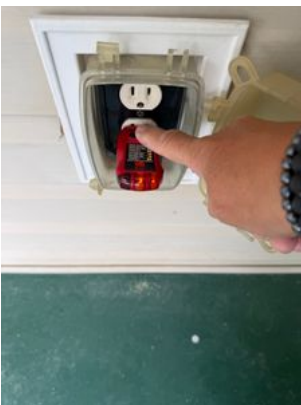
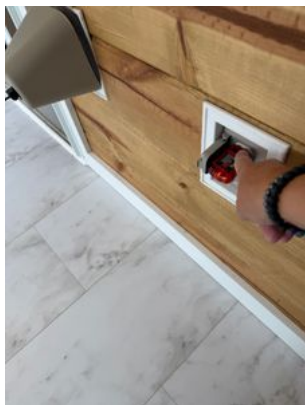
GFCI receptacles and weatherproof receptacle covers recommended at exterior.

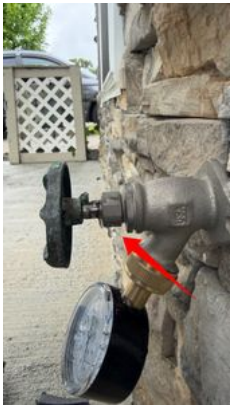
Exterior hose bib leaks during operation. Recommend repair / replacement as needed.

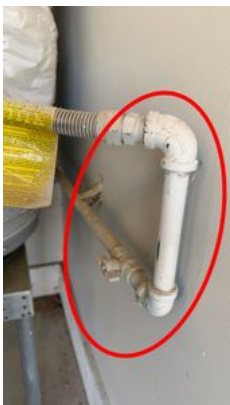
Recommend installing drip legs at gas supply lines as needed. None visible.

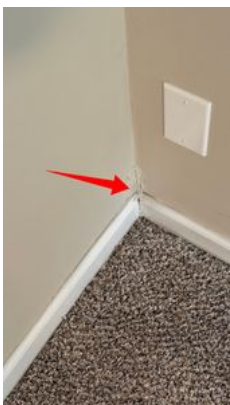
Moisture damage noted at wall base/corner. Likely ongoing or recurring. Source unknown. Recommend evaluation and repair.

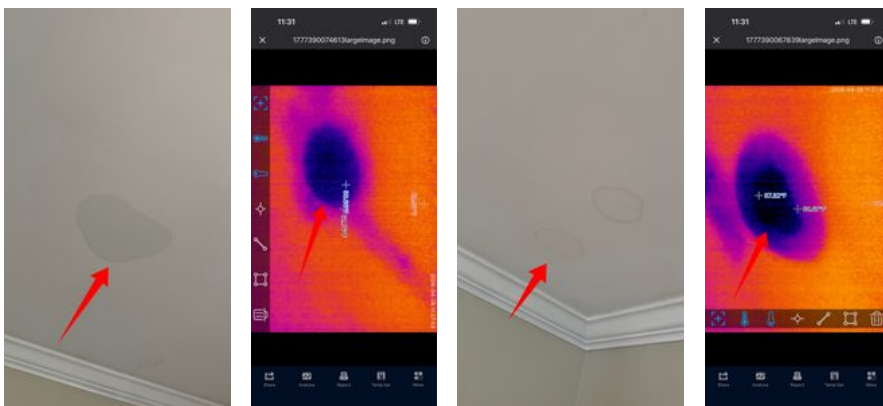
Ceiling is actively wet with visible staining. Source unknown. Recommend immediate evaluation and repair.

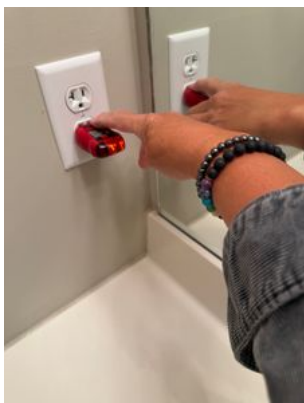
GFCI receptacles recommended within 6' of water sources. (Kitchen, bathroom (s), laundry room, etc.)

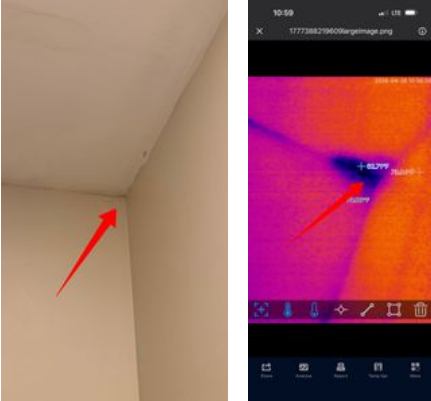
Active moisture noted at master bathroom ceiling above toilet. Thermal anomaly and visible damage present. Source unknown. Recommend immediate evaluation and repair.

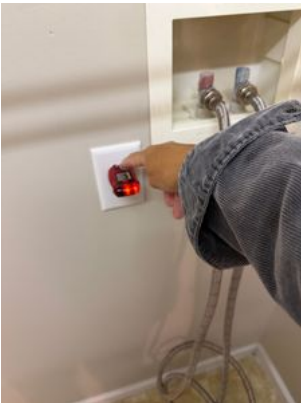
GFCI receptacles recommended within 6' of water sources. (Kitchen, bathroom (s), laundry room, etc.)

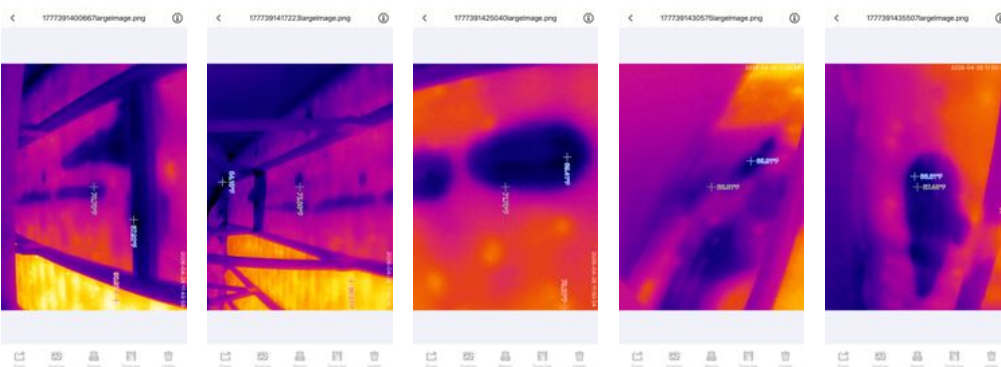
Thermal anomalies noted at roof sheathing/drywall interface consistent with possible moisture intrusion. Recommend further evaluation.

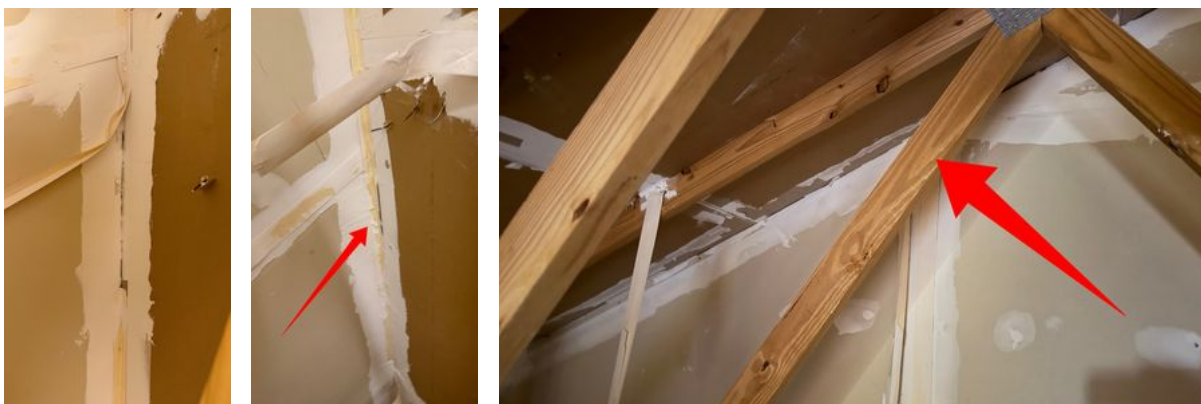
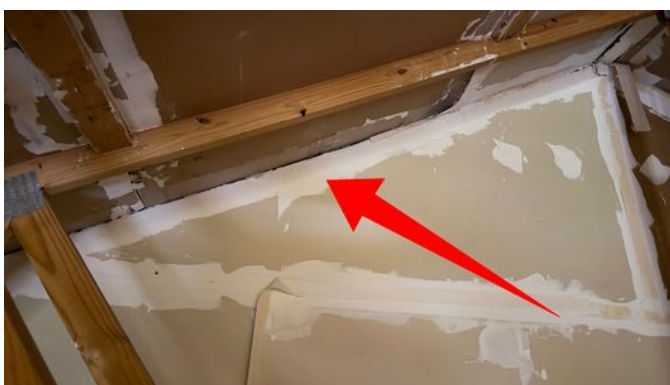
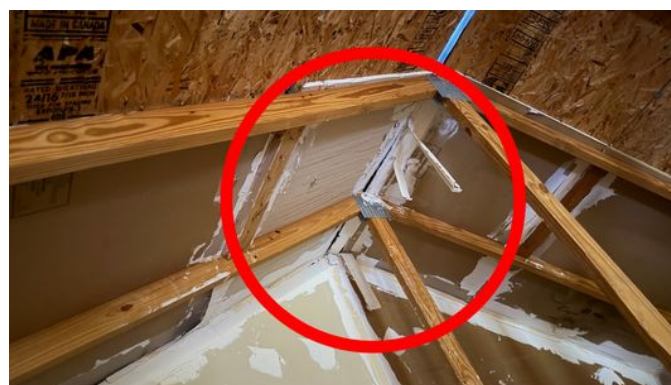
improper fire separation with openings—needs to be sealed and corrected, not just cosmetically patched.
