Insight Home Inspection Services

Home Inspection Report Report Summary

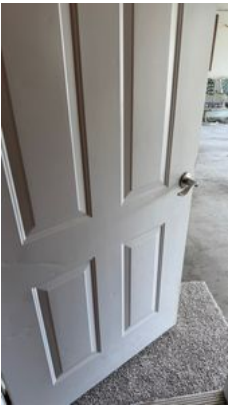
Garage

The garage door does not automatically close and hinge adjustment appears needed. A self-closing garage door is a fire and life-safety feature that helps prevent the spread of fire, smoke, and carbon monoxide from the garage into the living space. Recommend adjustment/repair by a qualified technician.

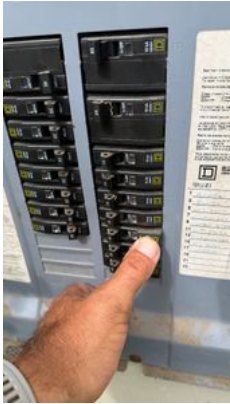
Electrical: GFCI/AFCI Breakers

GFCI / AFCI breaker would not trip. Recommend further electrician evaluation and repair as needed.

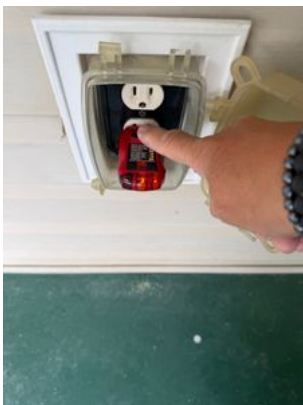
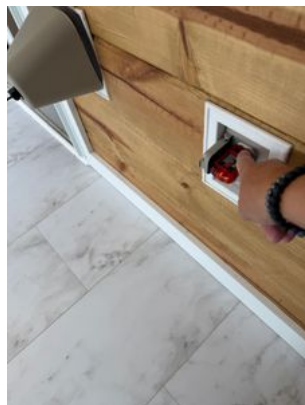
Electrical

GFCI receptacles and weatherproof receptacle covers recommended at exterior.

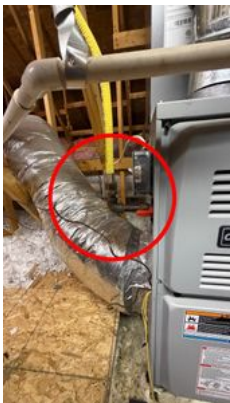
HVAC: Heating: Heating Fuel

Recommend installing a drip leg at gas line for the furnaces.

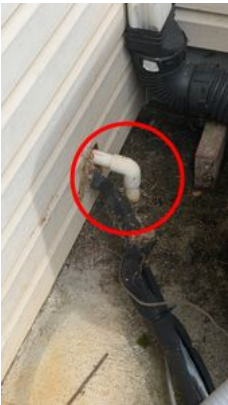
HVAC: Heating: Condensate Drainage

The HVAC condensation drain terminated less than 12 inches from the home's foundation. This can allow water to collect near the structure and contribute to moisture intrusion or foundation settlement over time. Recommend extending the drain line to discharge further away from the home.

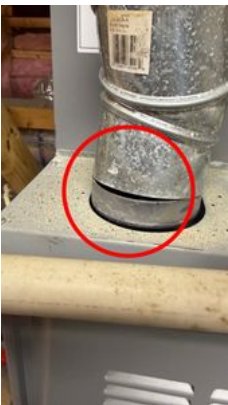
HVAC: Heating

Improperly installed flue connection with visible gap at furnace. Potential for exhaust gas leakage. Recommend repair.

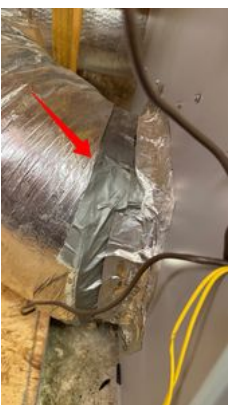
HVAC: Heating

Flex duct improperly secured at air handler. Tape used in lieu of proper fastening. Air leakage likely. Recommend correction.

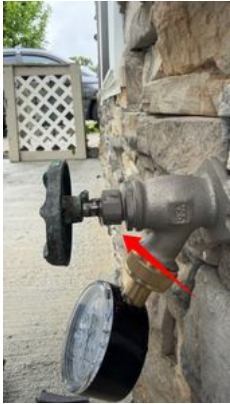
Plumbing

Exterior hose bib leaks during operation. Recommend repair / replacement as needed.

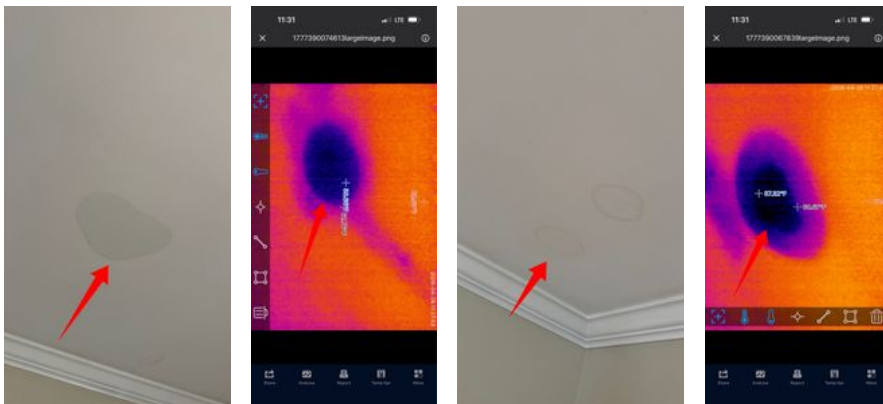
Interior

Ceiling is actively wet with visible staining. Source unknown. Recommend immediate evaluation and repair.

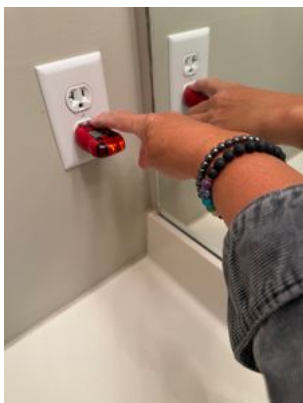
Bathrooms: Bathroom #1: GFCI Protection

GFCI receptacles recommended within 6' of water sources. (Kitchen, bathroom (s), laundry room, etc.)

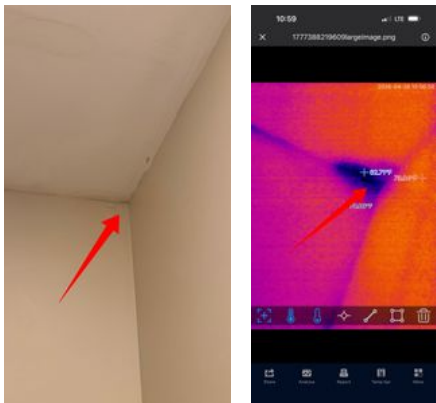
Bathrooms: Bathroom #2: Ventilation Type

Active moisture noted at master bathroom ceiling above toilet. Thermal anomaly and visible damage present. Source unknown. Recommend immediate evaluation and repair.

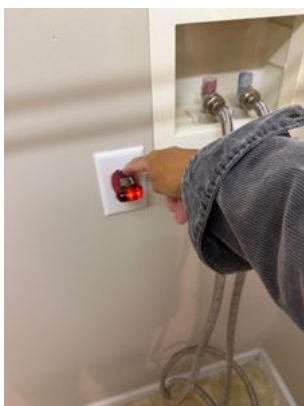
Laundry: GFCI Protection

GFCI receptacles recommended within 6' of water sources. (Kitchen, bathroom (s), laundry room, etc.)

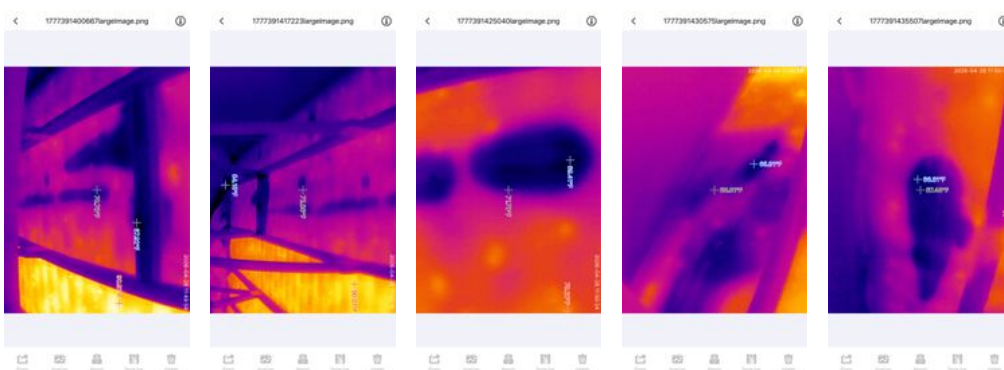
Structure: Attic: Roof Deck Material

Thermal anomalies noted at roof sheathing/drywall interface consistent with possible moisture intrusion. Recommend further evaluation.
