Insight Home Inspection Services
(865) 274-0808
www.inspectedbyinsight.com
info@inspectedbyinsight.com

Home Inspection Report

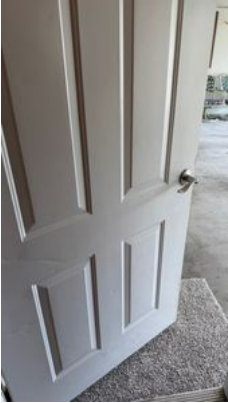
The garage door does not automatically close and hinge adjustment appears needed. A self-closing garage door is a fire and life-safety feature that helps prevent the spread of fire, smoke, and carbon monoxide from the garage into the living space. Recommend adjustment/repair by a qualified technician.

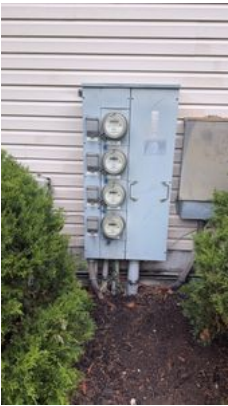
Underground electric service in place.

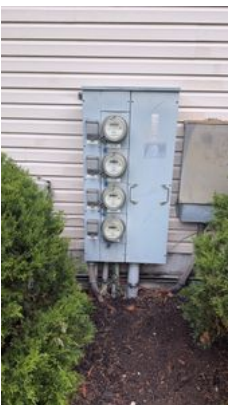
Main electrical disconnect is located at the electrical meter and service panel.

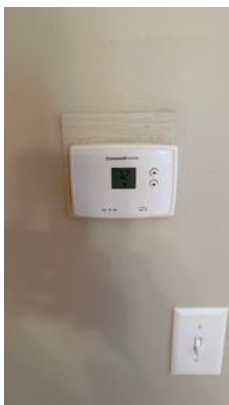
The thermostat was operational at the time of inspection.

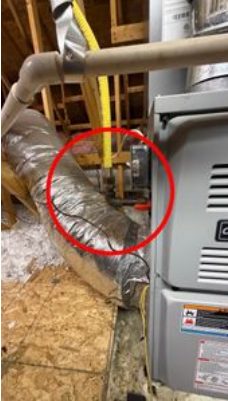
Recommend installing a drip leg at gas line for the furnaces.

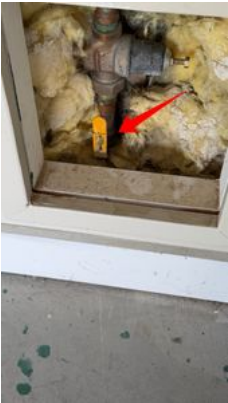
Main interior water shut off is located in the garage.

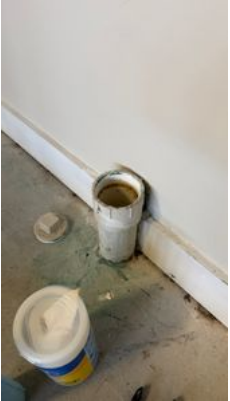
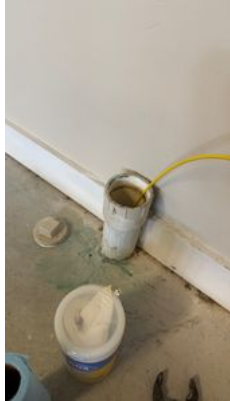
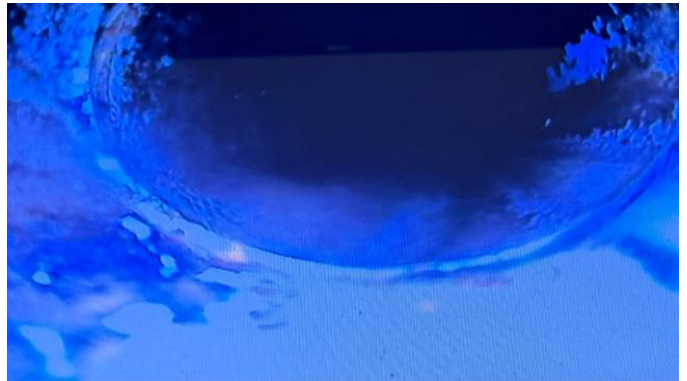
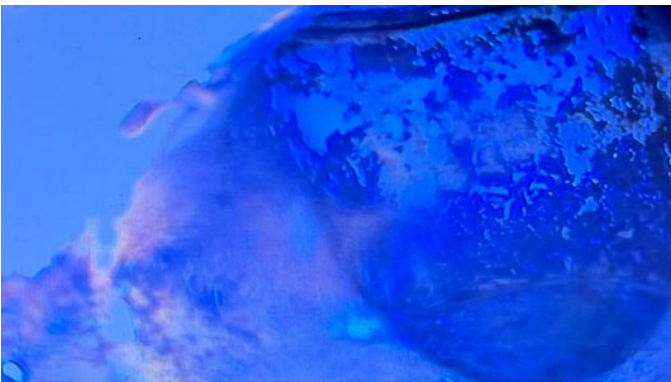
Sewer scope revealed lateral lines were clear and functional as designed.

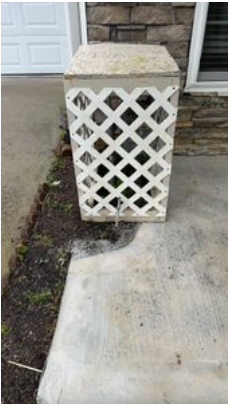
Main fuel shut off is located at the gas meter.

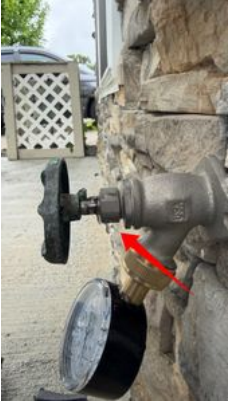
Exterior hose bib leaks during operation. Recommend repair / replacement as needed.

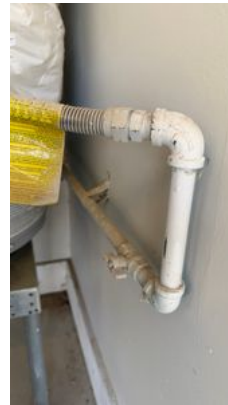
Water heater(s) was/were in normal working order at time of inspection. An expansion tank is recommended.

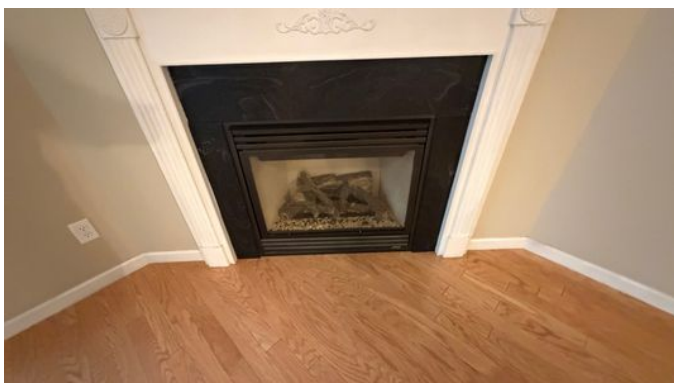
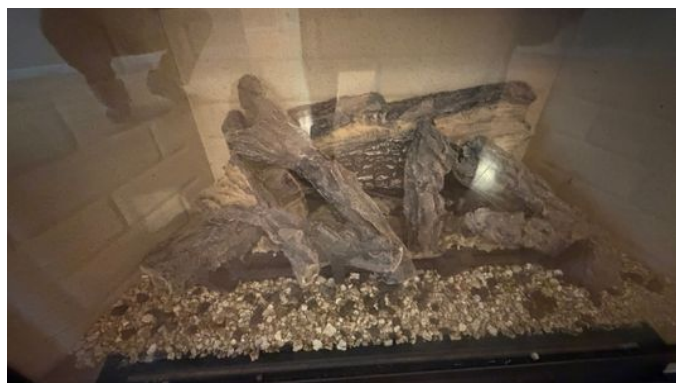
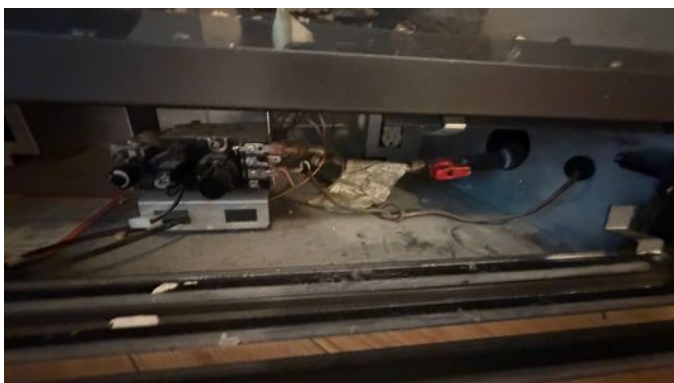
Gas fireplace was not in service at time of inspection. (Gas was turned off/pilot not lite)

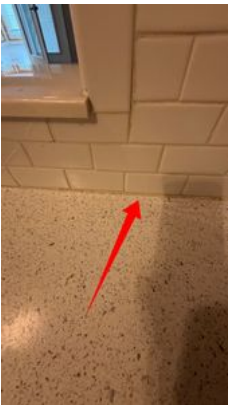
Comment 46 Information

Recommend caulking / sealing countertop edges and backsplash when needed.

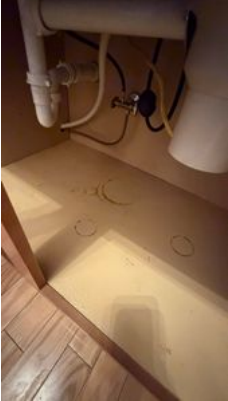
Comment 49
Information

Moisture stains present at cabinet. No moisture observed at time of inspection.

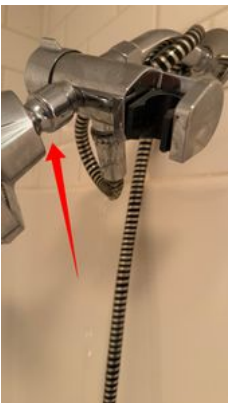
**Comment 56
Information**

Shower head leaks during operation.

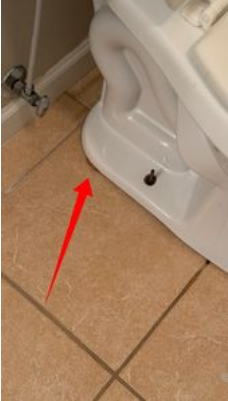
Comment 60
Information

Recommend caulking ceiling toilet at floor location.

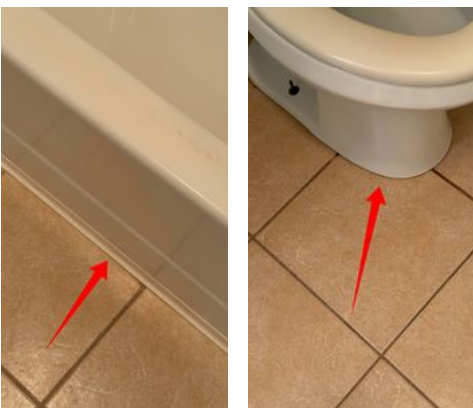
Comment 61
Information

Area in need of regular caulk / grout maintenance.

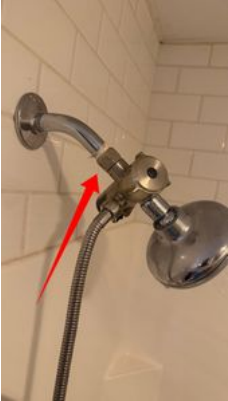
Comment 64
Information

Shower head leaks during operation.

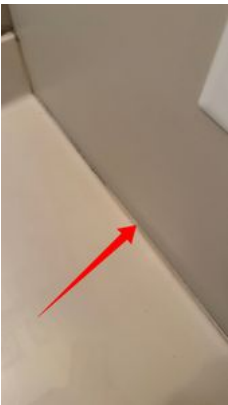
Comment 65
Information

Recommend caulking / sealing countertop edges and backsplash when needed.

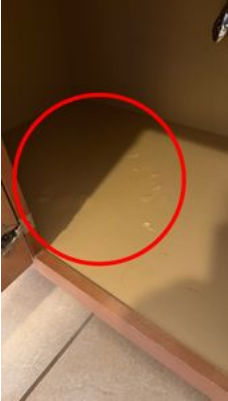
Comment 67
Information

Moisture stains present at cabinet. No moisture observed at time of inspection.

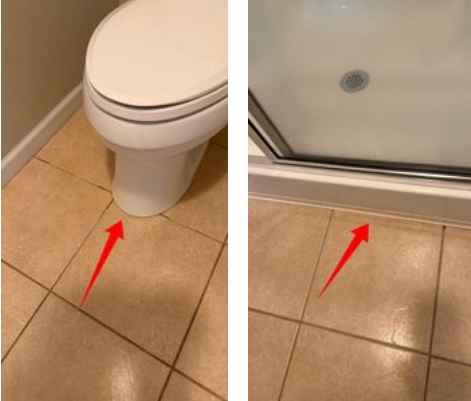
Comment 69
Information

Area in need of regular caulk / grout maintenance.

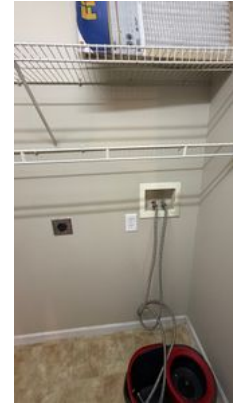
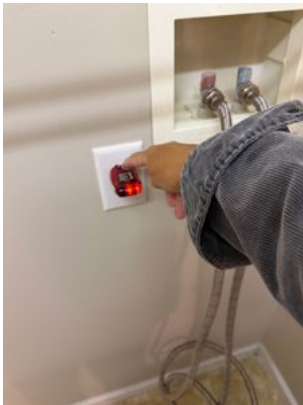
No appliances present, connections only-drains not tested.

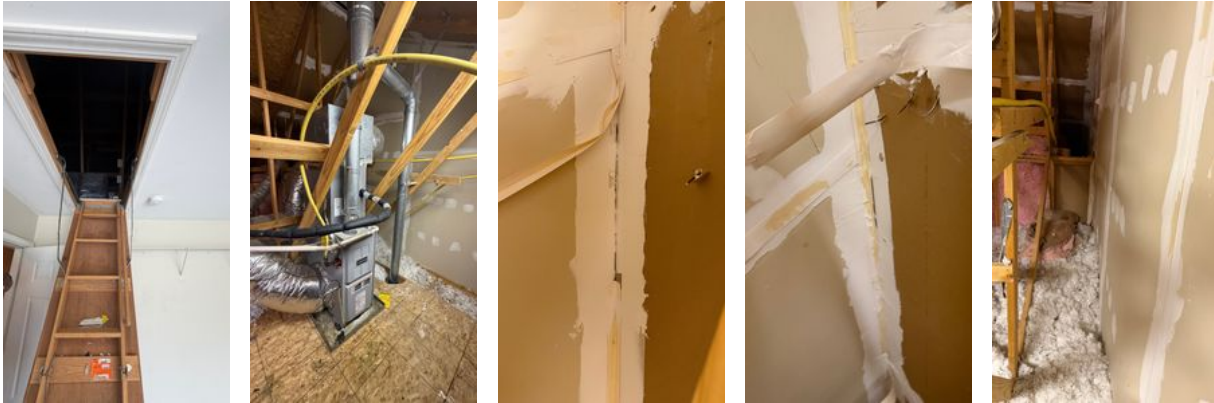
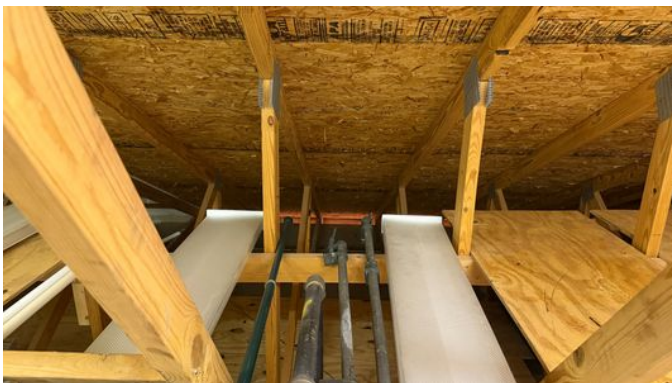
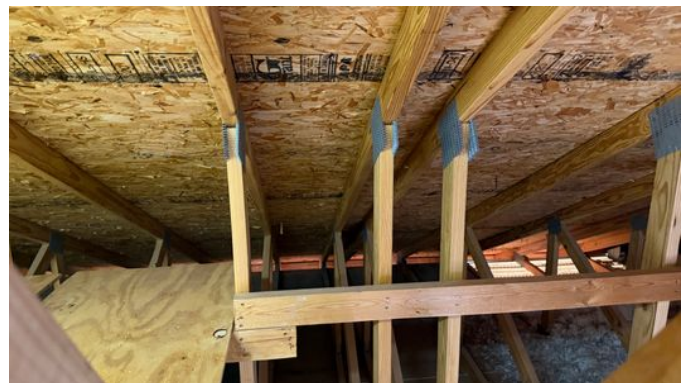
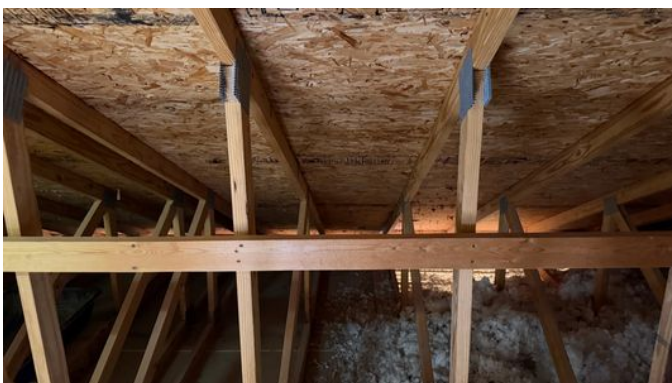
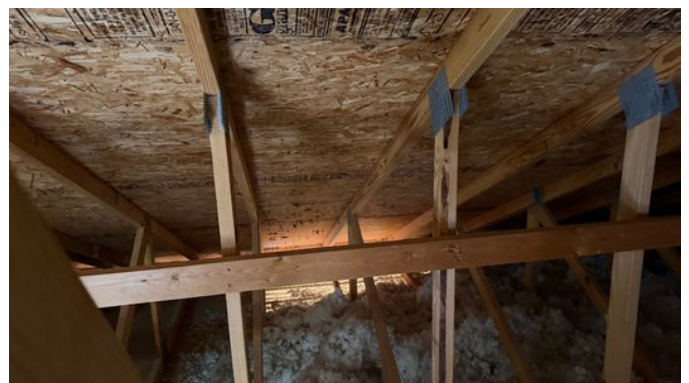
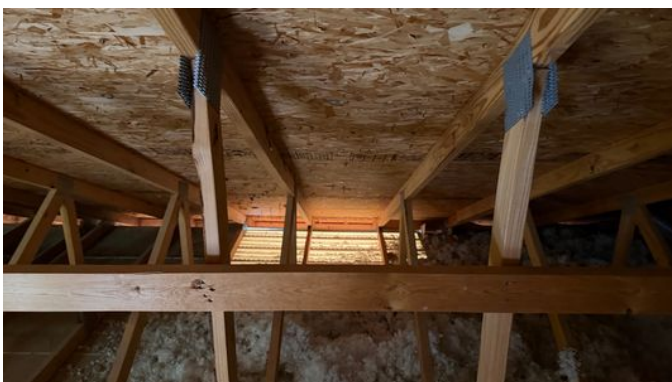
Comment 80
Information

Attic reference pics.

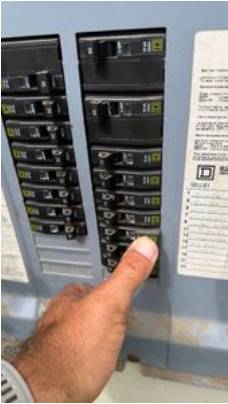
Electrical: GFCI/AFCI Breakers

GFCI / AFCI breaker would not trip. Recommend further electrician evaluation and repair as needed.

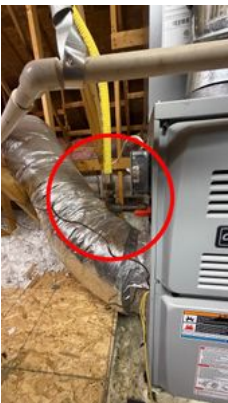
HVAC: Heating: Heating Fuel

Recommend installing a drip leg at gas line for the furnaces.
